Damage Analysis of Carbon/ Glass Fiber Hybrid Composite Pipes**Ahmet Faruk DOĞAN***Necmettin Erbakan University***Mehmet KAYRICI***Necmettin Erbakan University***İbrahim Çağatay GÜNAY***Necmettin Erbakan University***To Cite This Chapter:**

Doğan, A. F., Kayrıcı, M., & Günay, İ. Ç. (2025). Damage analysis of carbon/glass fiber hybrid composite pipes. In F. Z. Saltan, H. Arıkan, & Y. Uzun (Eds.), *Current studies in basic sciences, engineering and technology 2025* (pp. 108–138). ISRES Publishing.

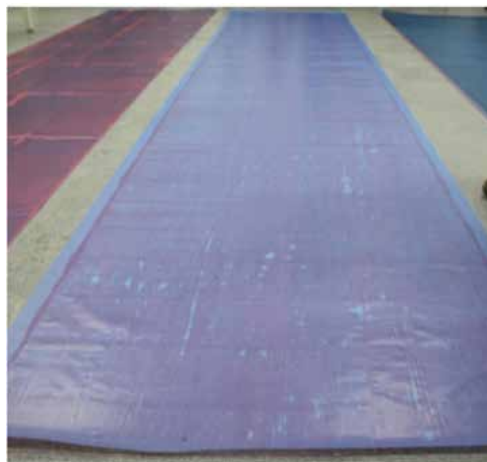
Figure 1

Glass Fiber Material

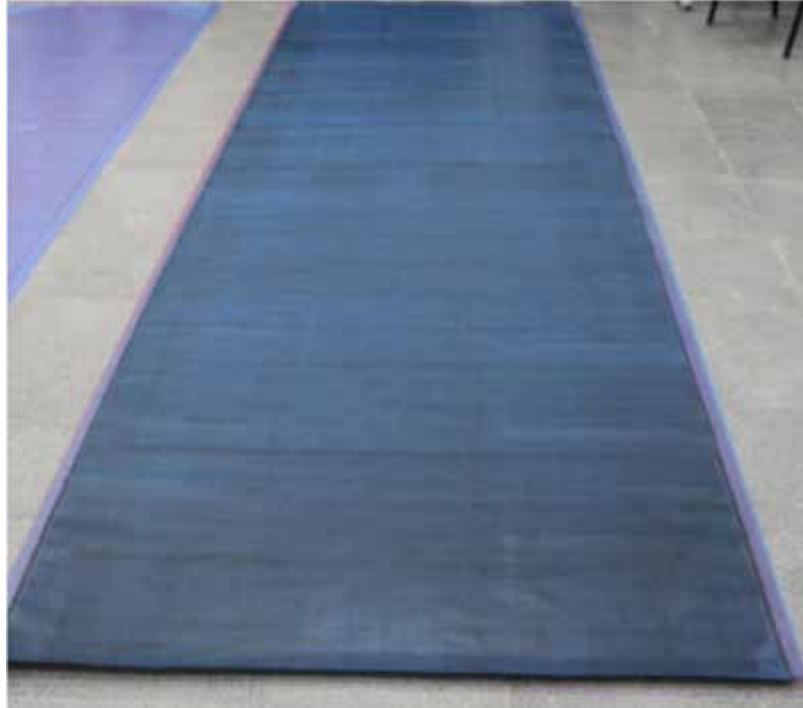
Figure 2

Carbon Fiber Material

In our study, Twill-430 gr/m² carbon fiber prepreg material was supplied from SPM Composite company by paying attention to cold chain transfer. Technical specifications of carbon fiber materials are given in Table 2 and the material supplied is given in Figure

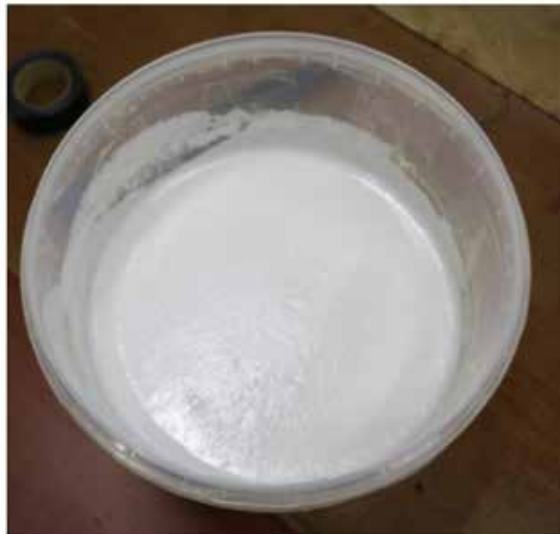
Prepreg resin VTP DA100 model material was supplied from SPM Composite Company. Since we could not produce nano doped prepreg material, considering the decrease in the resin / matrix concentration of the prepreg material, nano doping was provided by using the same prepreg resin in order to add nano doping to the prepreg material. The supplied prepreg resin material is given in Figure 3

Resin

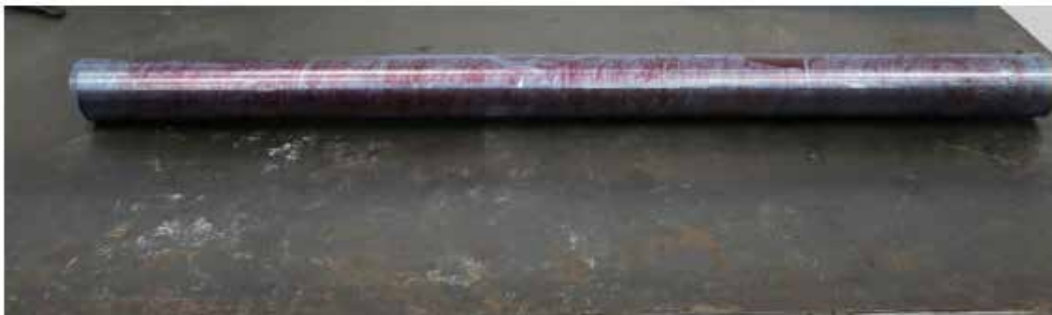
Figure 4

Cylindrical mold

The pipe used as a mold was obtained from seamless steel with an outer diameter of 72 mm and a length of 1300 mm by grinding the surface with a 0.1% taper. Our mold has a surface roughness value of N7 and the surface quality and taper are made to ensure easy mechanical removal of the composite material from the mold.

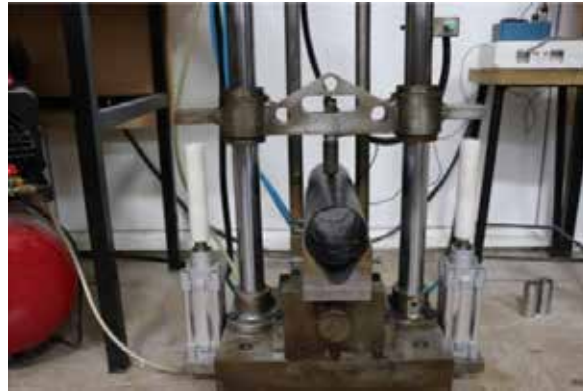
Figure 5*Low Speed Impact Device Test*

The specimens with and without carbon nanotubes were impacted at least 3 times each at 5J-10J-15J energy values with a device with a cylindrical nose geometry. Since the selected material was both carbon fiber and carbon nanotube, no color separation was observed in the damage zone and it was not possible to observe it with penetrant liquid. The specimens impacted at 5 cm intervals were cut from the impact damage zone with a band saw and the damage zones were examined with a digital microscope. The results of the examination are given in the relevant section. The low-speed impact testing machine we used in our study is given in Figure 5.

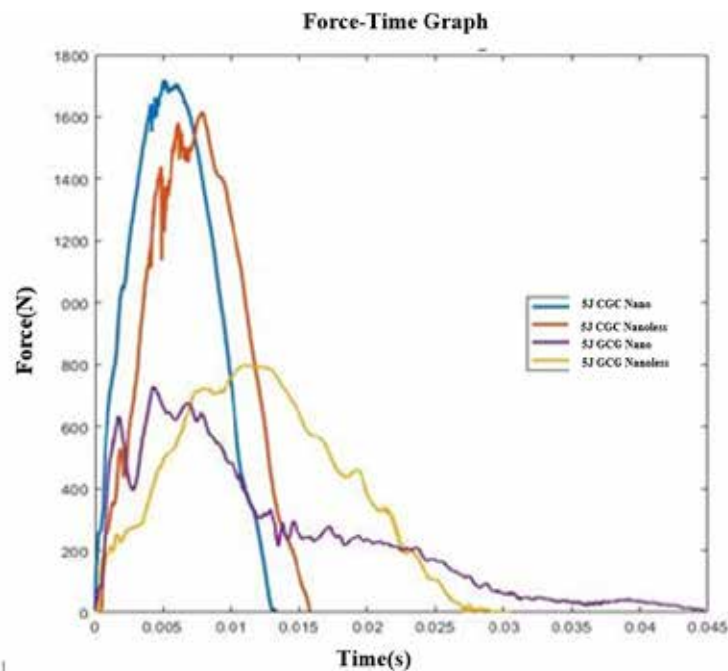
Figure 6*Test graphs with 5J*

The difference between the material with and without nanos in the CGC array at 5J is 150-200 N. Earlier matrix cracking damage propagation was observed in the material without nanos. In the GCG array, the damage propagation at the same forces occurred in a longer period in the nanosized material, which leads to the conclusion that the nano

reinforcement prevents the damage from spreading. Because the force contact time was realized in a longer period in the nanosized material. It is expected that the contact force is different between the CGC array and the GCG array. Because the CGC array is a stronger structure containing 8 times carbon.

Figure 6, Figure 7 and Figure 8 show the time-dependent variation of the contact force for different impact speeds. As can be seen, the contact force starts to increase at the first point of contact. This trend continues until Hertzian damage is encountered. Hertzian damage can be associated with matrix fracture damage encountered in the contact zone. However, the tubes may not lose their structural integrity and resist the applied deformation. Thus, an additional increase in contact strength is observed.

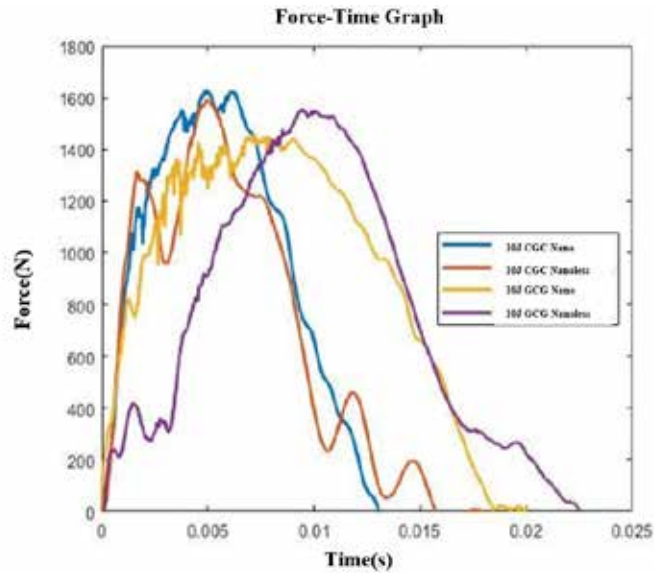
Figure 7
Test graphs with 10J

When the energy effect is increased, it is seen that the CGC array has a more stable structure in which the nanosilver materials have a larger force contact time compared to the materials with nanosilver and start to be damaged earlier.

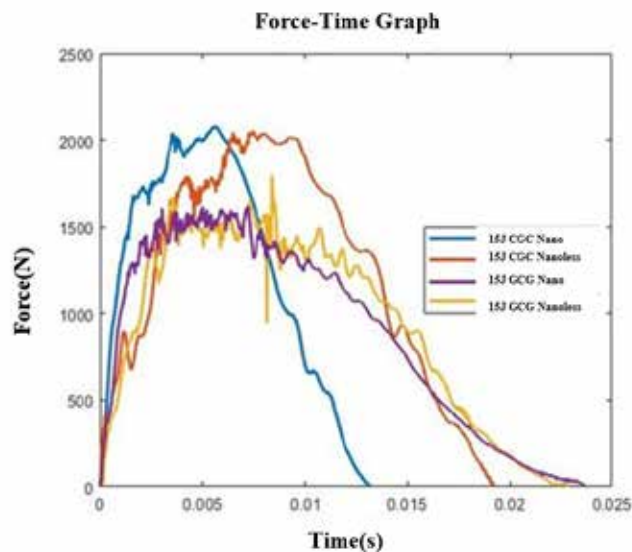
Figure 8
Test graphs with 15J

In this graph, it can be said that the CGC array has a more resistant and brittle structure, while the GCG array has a more elastic structure. In contrast to the sudden matrix and fiber fractures in the CGC array, the GCG array shows deformation in a wider area spreading at a slower rate.

In general, when the force is increased, it can be concluded that the structures with nanotubes are damaged in shorter time periods at higher forces, while in the GCG array, this time period is more, so the damage area is wider and the fractures are more at smaller sizes. 1% nanotube additive reduces the damage of the materials and increases the force strength, but it is thought that the impact strength will increase at a more predictable level by increasing the nanotube additive up to 3% in accordance with the literature.

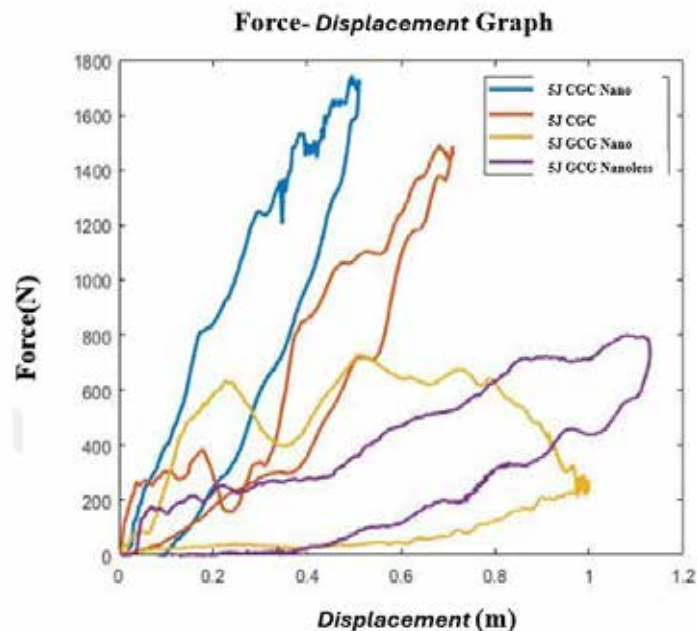
Figure 9

Test graphs with 5J

The material with CGC nanoparticles was destroyed at higher forces with a smaller displacement ratio and a stiffer rebound. In the non-nano material of the same array, lower force, earlier deformation, larger displacement and more moderate rebound occurred. In the GCG array, larger displacement and much lower rebound forces occurred due to a

more flexible impact glass fiber. The non-nanosized version of this array has a larger displacement and therefore a larger deformation zone. This may be due to the more rigid structure of the carbon fiber layer under the glass fiber layer.

Figure 9, Figure 10 and Figure 11 show the change in contact force versus vertical displacement of the pipes. The slope of the contact force-displacement curve represents the bending strength. As the contact force starts to bend the pipe, a lower bending strength is observed. When the maximum contact force is reached, the displacement is also at its maximum value. Then the rebound phenomenon starts. It provides the remaining bending strength by pushing the impact tip back.

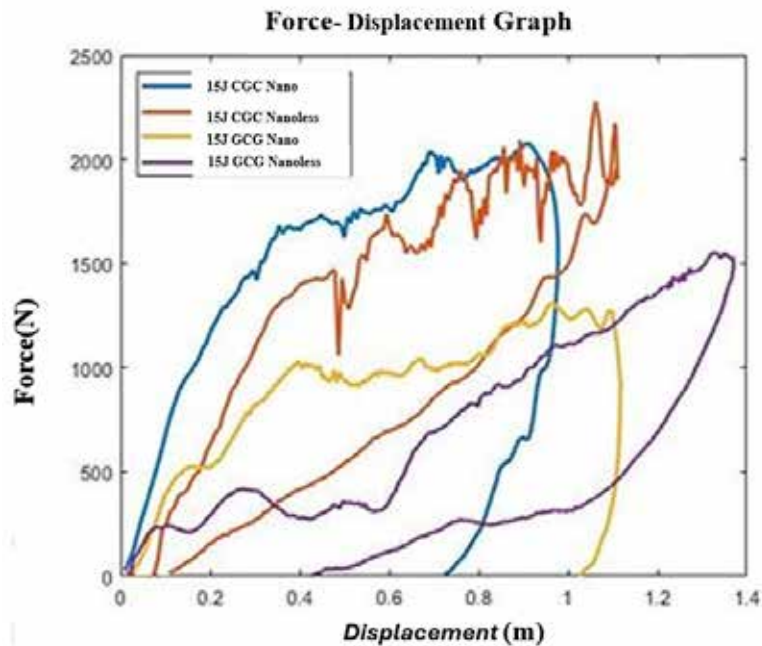
Figure 11*Test graphs with 15J*

At this energy level, the material with nanos in the CGC array suffered small-scale and large-area deformation damages, while the material without nanos suffered stiffer and sudden damages, but reached higher strength. In the GCG array, relatively lower forces, larger deformation area and displacement rates were achieved.

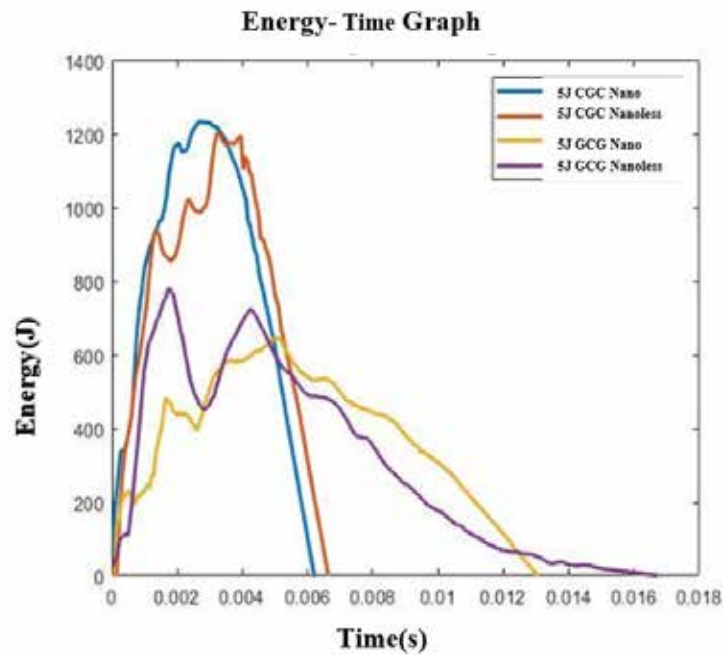
Figure 12*Test graphs with 5J*

In the CGC array, most of the energy in the samples with and without nanos was discharged in a very short time. The amount of rebound energy was also spent in a very short time. Here, the nano difference is evident even if it is very small. In the GCG array, on the other hand, since it has a weaker flexible structure in terms of strength, the energy levels were discharged in longer periods of time and the material was destroyed more severely. This is because the glass fiber has a weak structure.

Figure 12, Figure 13 and Figure 14 show the change in energy with respect to time during contact for different impact velocities. As can be seen, the majority of the impact energy was spent on deformation and a small amount of energy was used for rebound. It can also be seen that the contact time becomes larger as the impact velocity increases in this specimen.

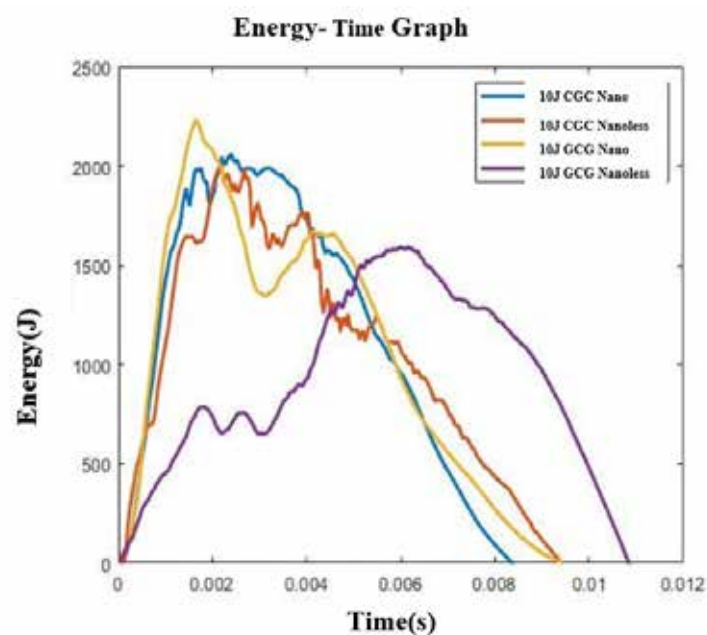
Figure 13*Test graphs with 10J*

At this energy level, there is a relative parallelism in the CGC sequence. Energy is discharged in almost the same periods. It is seen that the nanomaterial deforms in a shorter time and consumes energy. In the GCG array, on the other hand, there is a sudden energy discharge due to high energy levels and high degree of fiber breakage in short periods. The reason for this should be further investigated. In the non-nano form of the same array, there is energy discharge with matrix breakage at lower energy levels and then energy increase with fiber strength. Due to its flexible structure, energy discharge occurred in a wider time period.

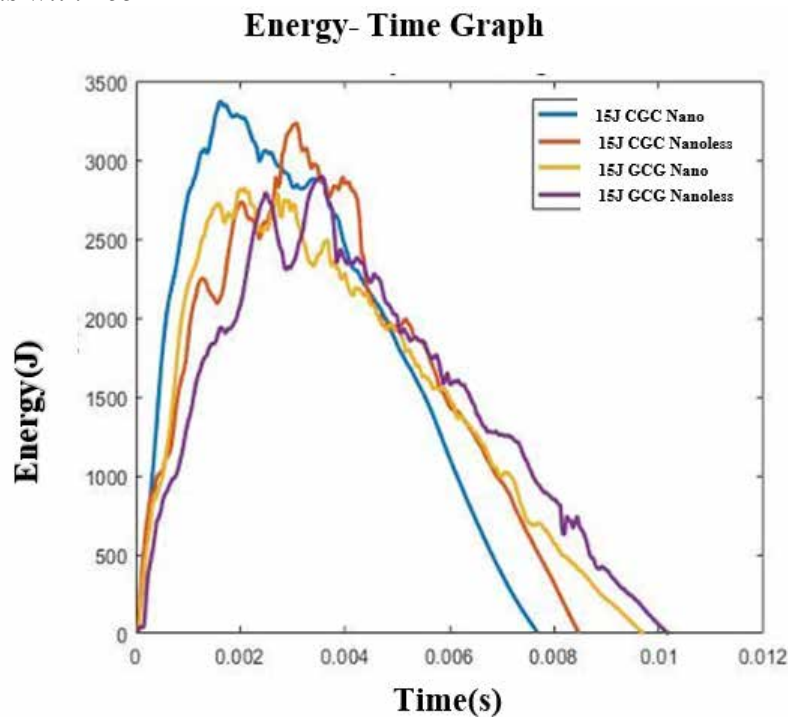
Figure 14

Test graphs with 15J

There is a correlation at this energy level for both arrays. All specimens were deformed with small matrix fractures, but again the materials with nanos were more severely damaged in shorter time periods. In the GCG array, especially the non-nano material was deformed with larger fiber fractures over larger periods of time.

Since the CGC array has a more stable and rigid structure in terms of strength, it absorbed more energy and spent this energy through matrix and fiber fractures. In the GCG array, there is a deformation with larger time periods and lower amplitude.

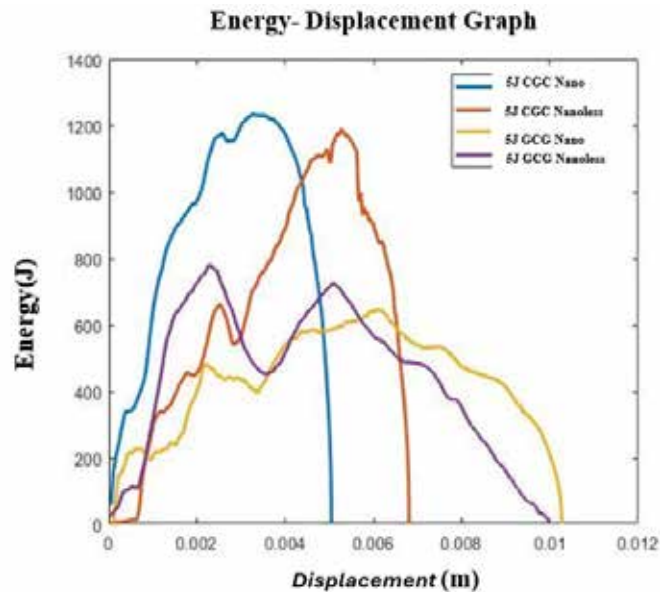
Figure 15

Test graphs with 5J

At this energy level, a higher amount of energy in the CGC array can be considered as a measure of the strength of the material as it creates lower displacement amounts. The fact that the nanoporous material in this array has a more stable structure shows the effect of nanotube doping. Despite the high level of energy expenditure, very small displacements were realized. The material without nanos has a larger displacement level with severe deformation damage. In the GCG array, since both samples have a more flexible structure, the structure with nanotubes consumed more stable energy and the structure without nanotubes was observed to deform with serious fiber fractures in a longer period.

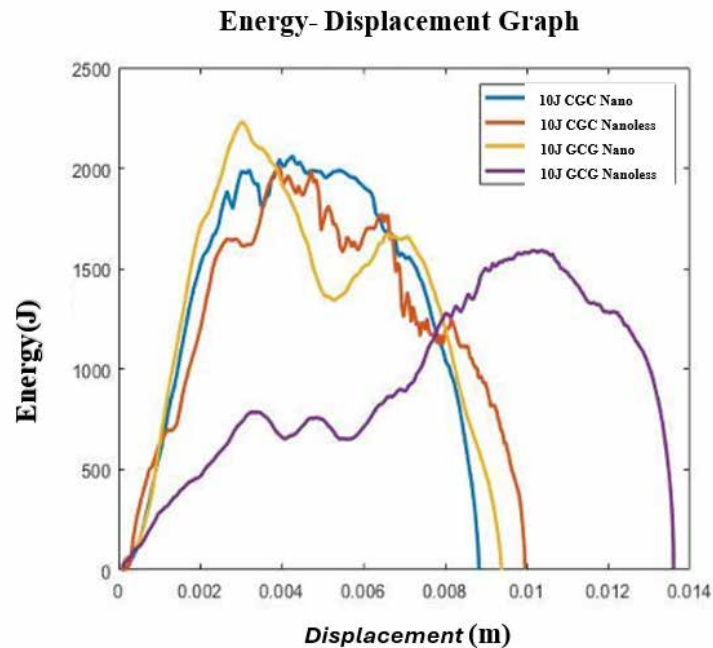
Figure 16*Test graphs with 10J*

At this energy level, there is an equilibrium that does not resemble the nanotube difference of the CGC array. Sudden fractures, albeit very small, indicate a sample without nanotubes. In the GCG array, the material with nanotubes has a serious strength that we do not know the reason, but it absorbed energy at lower displacement rates due to very serious fiber fracture. The sample without nanotubes showed a more flexible structure and showed large displacement at low energy levels due to low stiffness.

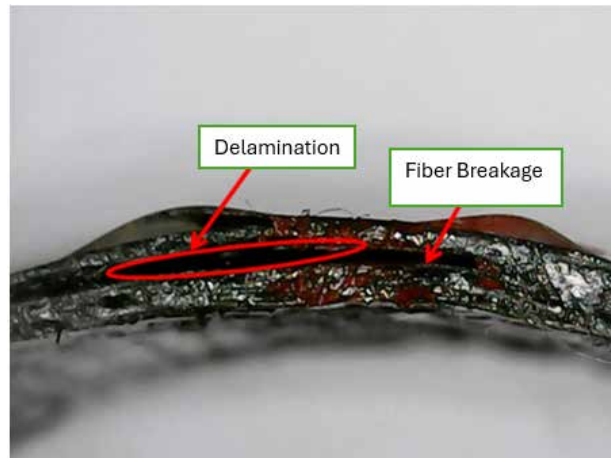
As the energy levels increase in the nanomaterial, the number and orientation of fiber fractures in the damage zone increases. Delaminations are more balanced but tend to occur between the arrays. As the energy levels increase, the delamination lengths increase and the number of small delaminations increases in different regions.

- As the energy levels increase in the CGC nanofiber material, the number of fiber fractures and their orientations increase in the damage zone. Delaminations are more balanced but tend to occur between layers. As the energy levels increase, delamination lengths and numbers increase.
